INEEL/EXT-99-00678

Long Term Corrosion/Degradation Test First Year Results

Idaho National Engineering and Environmental Laboratory

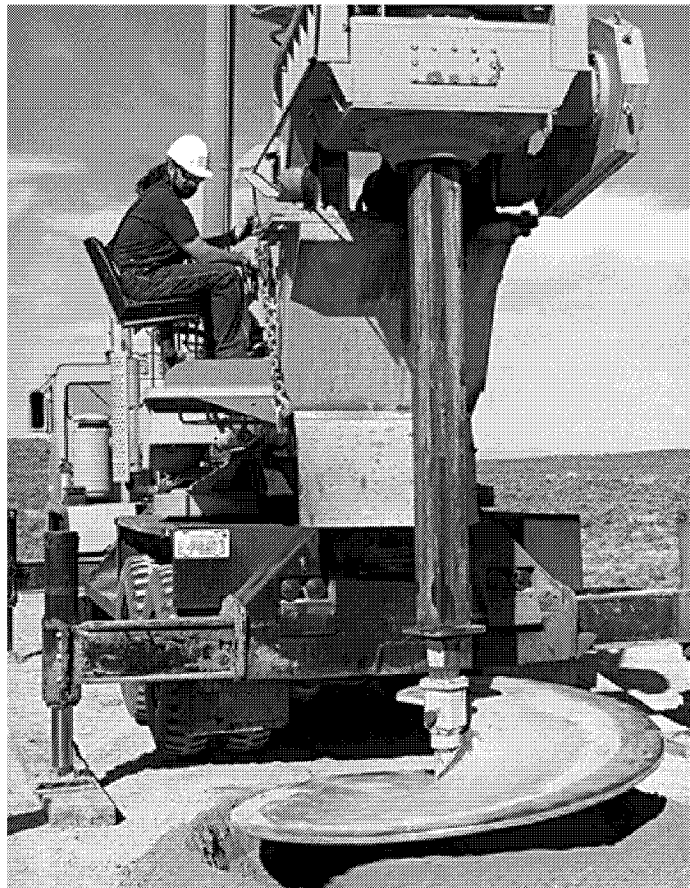
Figure 10. Drill rig with 6-ft-diameter auger.

In the autumn of 1997, coupon arrays were buried at depths of 4 ft and 10 ft at each of the four locations identified in Figure 4, for a total of eight coupon arrays. The 4- and 10-ft corrosion array burial depths were chosen to represent the activated core components that are buried from 4 ft to a maximum of 20 ft below the surface. The 4-ft depth provides a high level of exposure to changing environmental conditions, while the 10-ft depth more closely represents actual buried waste storage conditions. At each location, a hole was drilled using a drill rig equipped with a 6-ft-diameter auger (see Figure 10). Coupon arrays, each consisting of six polypropylene rod assemblies, were placed in the holes, with nine inches separation between the rods. A typical coupon array placed in a hole is shown in Figure 11.

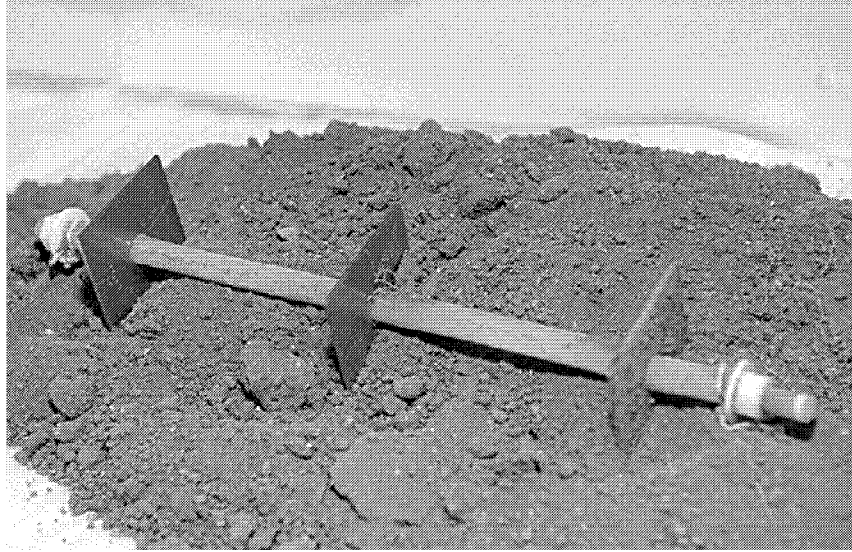
Figure 13. Rod from coupon array after removal from transport container.

After coupon arrays CA01 and CA02 had been exposed to corrosion conditions for approximately one year, they were removed for corrosion measurement. The coupons were recovered by reopening the hole with a backhoe, manually, and with the 6-ft auger drill. The backhoe dug to 3 ft, then the hole was manually opened from the 3-ft level to the 4-ft level, and CA01 was removed. The drill then dug to approximately 8 ft, with the remaining soil excavated manually. (Experience proved that it would have been better not to use the backhoe, since it caused the top edges of the hole to be unstable.) The coupons were extracted carefully from the hole, with care not to loosen the soil around them. The excavated coupons were transported in containers to the appropriate laboratory, disassembled, and the corrosion products sampled. A typical transport container is shown in Figure 12. The coupon array after transport to the laboratory is shown in Figure 13.

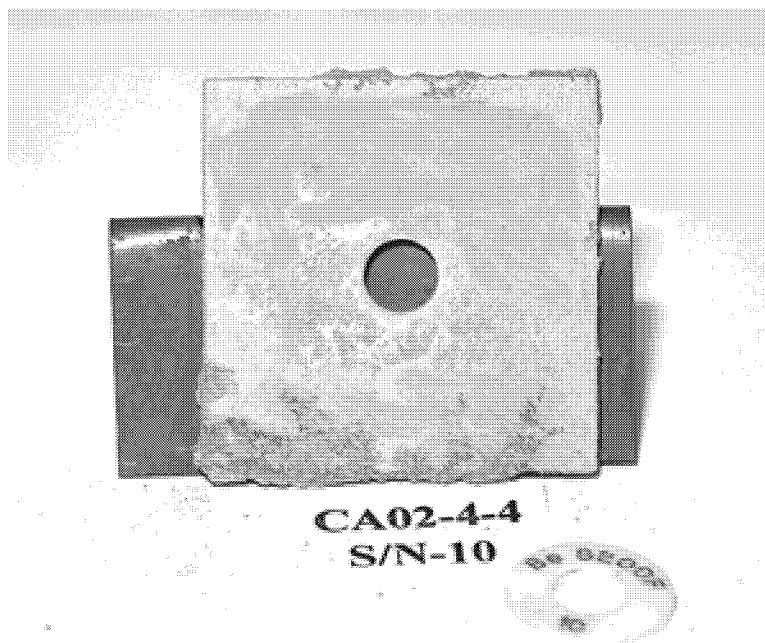
Figure 15. Beryllium coupon, after exposure, before cleaning

The beryllium coupons had corrosion rates measured from 0.152 MPY to 0.202 MPY. One of the exposed coupons is shown in Figure 15 with a surface corrosion product. Figure 16 shows the same coupon after cleaning, with pitting being evident.
